## Photographs of Hole in Silbury Hill, Update Part 1

**June 14, 2000 Silbury Hill, Wiltshire, England** - Around 3700 B. C. - almost 6,000 years ago by some estimates - an enormous complex of stone avenues, stone circles and the largest artificially constructed mound in all of Europe were created in Avebury, England. The huge artificial mound that rises 130 feet and covers five acres at its base is known as Silbury Hill. Two weeks ago on May 29th, a large hole was discovered on top. The last time there was any such wound in the great hill was 1776 when the Duke of Northumberland decided to look for buried treasure inside. When he found nothing, his workers closed up the shaft they had dug - perhaps only "capping" the top - which apparently now more than 200 years later has sunk in. Witnesses also reportedly saw unidentified lights near Silbury Hill and the West Kennett Long Barrow around the end of May and first of June, but no one knows if there is a connection to the large transforming crop formation that appeared June 1-2 in the West Kennett Long Barrow, followed by two more large formations on June 11, 2000 in the barley field right next to Silbury Hill.

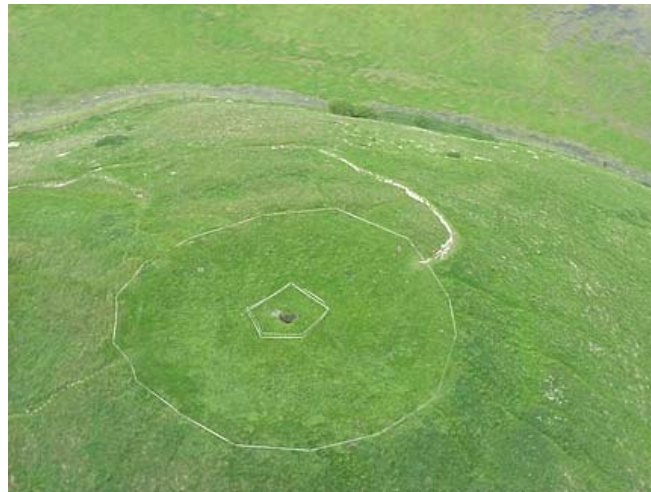
Seven foot square shaft that unexpectedly opened up in top of 6,000 year old Neolithic Silbury Hill and reported to local Avebury, Wiltshire police on May 29, 2000. Britain's private conservation charity, the National Trust, sealed off the hill for public safety and repairs. Photograph © 2000 *Wiltshire Gazette and Herald*.

"The hillside is a flat grassy summit on a big conical hill 130 feet high. The grassy summit is perhaps 50 or 60 feet in diameter. And there are a number of shallow depressions in the turf. And in one of these shallow depressions was this ragged hole in the turf perhaps 5 feet across. It had freshly broken, so the turf was hanging dangerously into the hole. If you lay down and wriggled towards the hole and peered down inside, once your eyes had adjusted you realized it was just the opening of a vertical shaft rather wider than the tear in the turf at the surface. The shaft was about 7 feet square. And once your eyes had adjusted you could see that it was 30 to 40 feet deep. Our measurement was about 34 feet.

The private British charity called the National Trust that cares for Neolithic and other sacred sites in the United Kingdom is responsible for the repair and preservation of Silbury and has sealed off the hill while engineers and archaeologists decide what to do. Today, I talked with the National Trust's Avebury Property Manager, Chis Gingell, who inspected the hole in Silbury shortly after the police were notified on May 29th. I asked him what he could see.

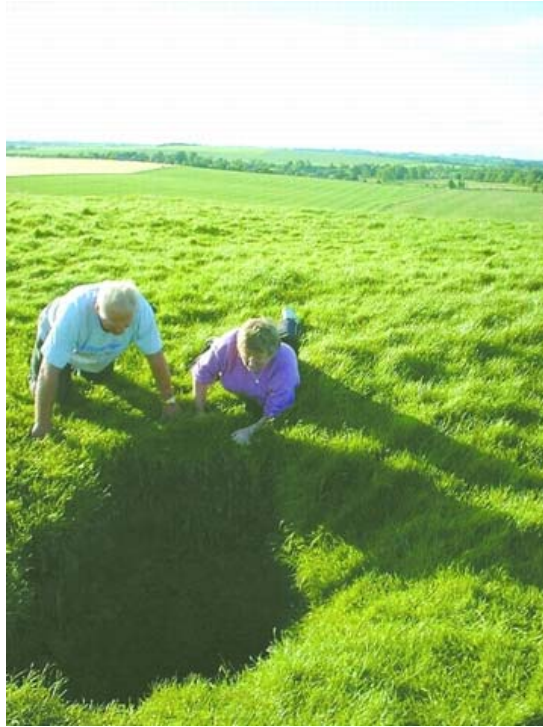
Local residents inspecting the unexpected hole that opened in the top of ancient Silbury Hill, Wiltshire, England on May 29, 2000. National Trust Manager, Chris Gingell, had the Neolithic mound sealed off while engineers and archaeologists decide

what to do for archaeological documentation and repairs.

No, it's just cut, clean cut through the chalk rubble. And what you can see is the way the capping of chalk rubble - this is local soft limestone - the way this capping has broken at the surface. It appears that early miners, probably almost up to the 20th Century, were in the habit once they had finished with a mine shaft, not of filling it completely, but simply of capping it. To do that, they put in a timber platform. It might be one of the platforms they actually used when they were digging the shaft, boarded over and poured ground rubble on top of that just a few yards thick at the top of the shaft. Really just plugging the top of the shaft. And in areas in Britain where there are long histories of mining, there is a continuous problem of mine shafts opening up in this way.

That's right. The bulk of chalk and soil excavated from that probably wouldn't have fitted on the narrow summit around the mouth of the shaft on top of the hill. In other words, some of it would have spilled over the sides of the hill. And I imagine what happened is that when they finished the shaft when the excavation was completed from their point of view, disappointed not to find some sort of great burial in the center of the hill, what soil and chalk was left in their heap at the top of the hill, presumably would have been shoveled back down the shaft. And then a certain part of it was kept back to cap or plug the mouth of the shaft itself. And it's that plugging that has finally collapsed down into the shaft.

however, that we can't get a first class photographic and measured survey of the hole itself with remote-controlled cameras - both video and still cameras - methods called photogrammetry, which is taking photographs from fixed positions so you build up a continuous carefully positioned sort of photographic image of inside the shaft. A technique like that is quite possible. But the shaft itself, the material through which it was dug - although an ancient man-made feature is still a man-made rubble mound. The material around the shaft is extremely unstable. The only way you could get safe access to it would be to line it and lining it would be self-defeating because you couldn't actually then examine the sides of the shaft that you wish to. So, I think the first choice will be to use remote-control cameras.
